Arch Cape Community Drinking Watershed Protection 2018 (Phase II)

# ONION PEAK HOLDINGS PROPERTY MANAGEMENT PLAN

NOVEMBER 2017 – PUBLIC DRAFT 1

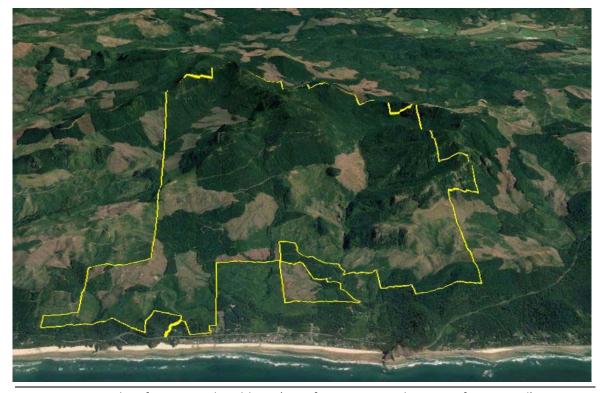
Map 3. Topography of Onion Peak Holdings (map facing east, Arch Cape in foreground).

The Onion Peak Holdings are situated in the Coast Range: Volcanics Ecoregion. The lower lying western areas of the property are mostly gradually sloped and underlain by sedimentary rocks (see Map 3). These areas give rise to steep and dissected extrusive igneous ridge and peaks composed of breccias, basalt flow rock and pillow basalt. Onion Peak is the most prominent

landmark of the Property and part of an impressive U-shaped ridge system that forms a cirque. Other defining topographic features of the Property include a steep east/west running canyon formed by Arch Cape Creek and the prominent ridgeline that includes Angora Peak (which is situated just south of the ownership. Elevation ranges from 40' at the extreme west edge of the Property to a highpoint of 3,060' on Onion Peak.
